# APPENDIX B - ENERGY AUDIT

As part of the Rogue Valley International – Medford Airport (MFR) Master Plan effort, the terminal building located at 1000 Terminal Loop Parkway underwent an energy audit. The overview of the Energy Audit includes the following sections:

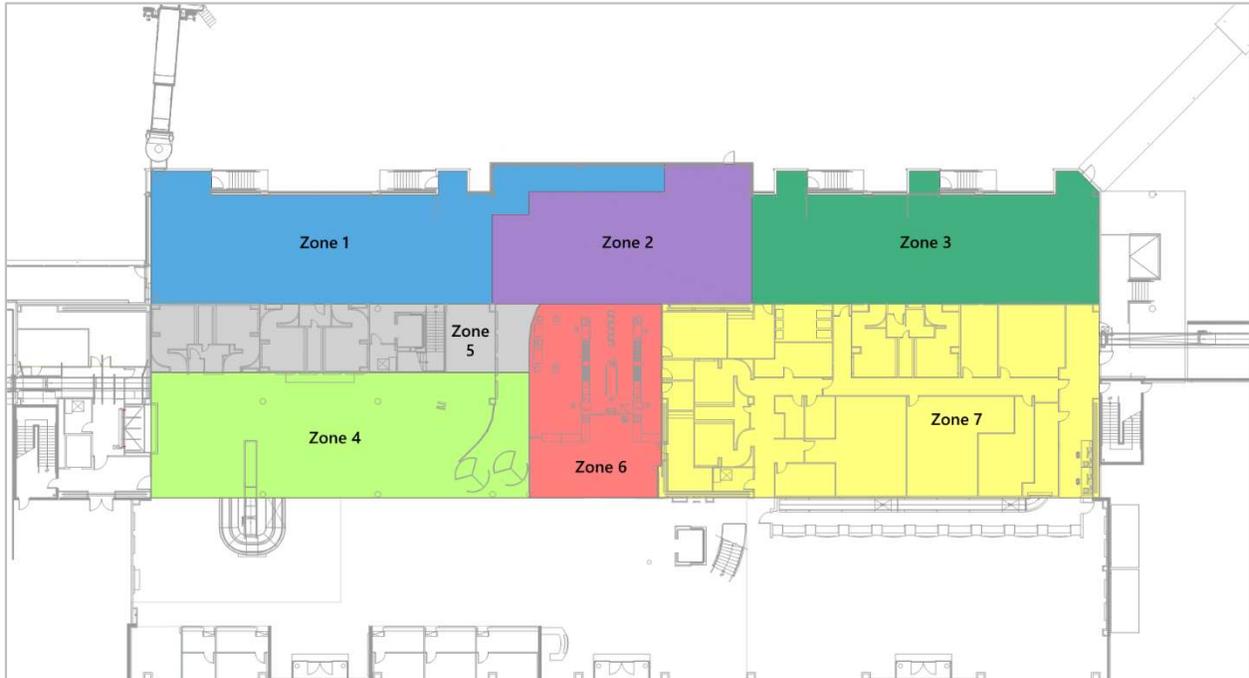
**Figure B-2: Air Conditioning Unit Zones of Control- First Floor**

The main facility is served by 18 AC units located on the roof, and three additional units mounted at grade serve the baggage areas. A majority of the AC units on the roof (15 of 18) have an associated ERV to temper the outside air during minimum outside air conditions. Each unit is controlled by a dedicated thermostat located in the associated zone (Example: Zone 18 is served by AC 18).

Zone 18 is the administration area and consists of common areas and individual offices on the same zone. The offices are occupied regularly and see drastic fluctuations in temperature in comparison with the much larger adjacent spaces. The ventilation ductwork to the offices has been terminated and individual heating cassettes installed in each office. Heating is provided by a condensing unit located on the roof.

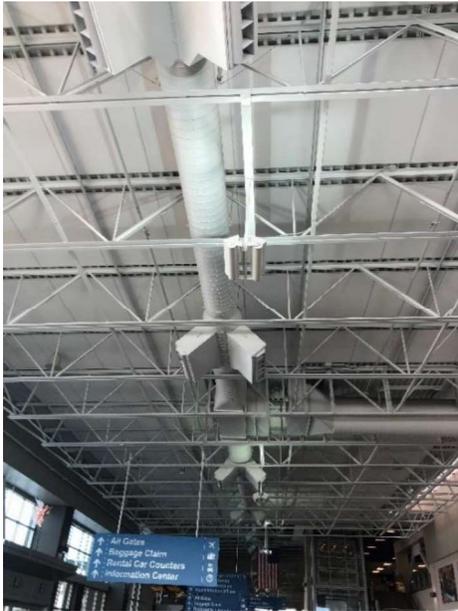
**Figure B-4: 400W Metal Halides in Ticketing and Baggage Claim**

Metal halide fixtures currently illuminate the ticketing and baggage claim areas. There are 16 400-watt (W) metal halide fixtures providing the general lighting within the ticketing and baggage claim areas (See **Figure B-4**). In addition, 14 metal halide fixtures at 250W each are washing the walls of the space.

There are 16 metal halide fixtures of 400W each providing the general lighting within the ticketing and baggage claim areas shown in **Figure B-4** and 14 metal halide fixtures of 250W each washing the walls of the space. These fixtures are considerably less efficient and reject extensive amounts of heat to the space. The fixtures are original to the facility and nearing the end of their useful life.

**Recommendation #4 and #5:** Replace the metal halide fixtures within the next five years with the LED version of the lights or similar LED feature lights.

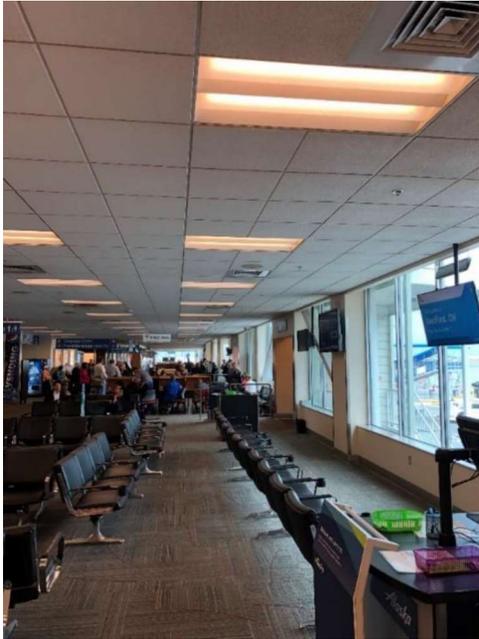
Figure B-5: T-5s in Boarding

The facility boarding area and other customer areas are illuminated with energy efficient T5 fixtures with on/off daylight harvesting control. At the time of the site visit all boarding lights were “On” and we did not witness lights cycling on and off. Large open areas are commonly susceptible to nuisance switching called “cross-talk” when on/off daylight harvesting is implemented in open spaces.

The facility boarding area and other customer areas are illuminated with energy efficient T5 fixtures with On/Off daylight harvesting control. The lights were primarily on during all times during the site survey however On/Off systems are susceptible to control challenges on partly cloudy days and days with varying outdoor conditions.

**Recommendations #6:** Update all lighting to LED fixtures to reduce energy consumption and minimize maintenance costs.

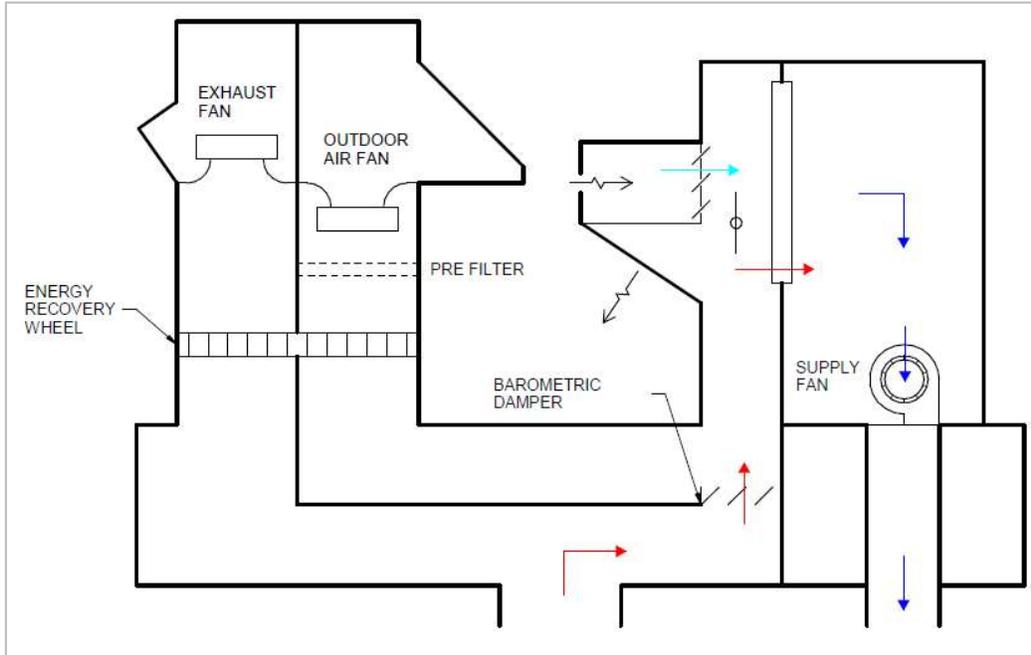
**Figure B-6: Unit Operation in Current Condition**

The ERV systems were found to be disabled. Each facility member interviewed while on-site expressed the “wind tunnel” effect when the ticketing doors and boarding doors are open simultaneously. During the interview with the staff they indicated the units were disabled as the result of the extensive amount of outside air being drawn into the facility through the front doors and the boarding doors. The air infiltration (wind tunnel effect) is partially due to the associated AC units shutting down as mentioned above. Disabling the ERVs disables the Outside Air (OA) fans within the ERV, which induces pressure drop on the AC supply fan causing a drastic decrease in air flow shown in **Figure B-6**. Un-tempered air enters the facility through the doors when opened causing temperature fluctuations within the facility.

**Recommendation #1:** Clean, replace the filters for, and enable the ERV Units. Activation of the ERV and associated fans will result in higher outside air flow and more stable building pressurization shown in **Figure B-7**
